BENSON CITY HALL/POLICE DEPARTMENT

FACILITY ASSESSMENT AND FEASIBILITY STUDY

**Prepared for the City of Benson, Minnesota
by Widseth Smith Nolting**

May 2016

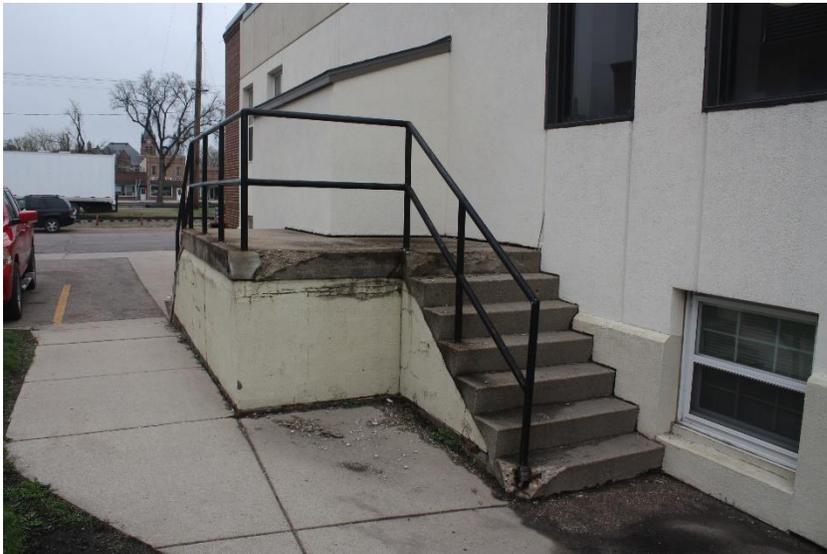
An unused exterior stair is located on the west side of the building. The stair is concrete and is deteriorating.

Recommendation: Demolish this stair and patch the adjacent building area

Cost Opinion: \$18,000

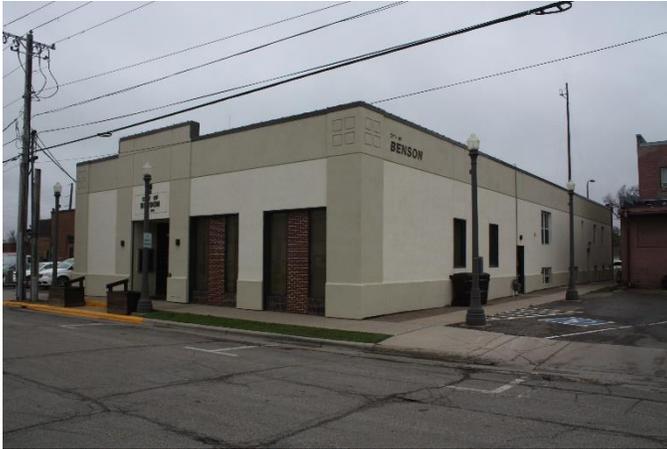
The existing roof is a rubber membrane roof and is in good condition. Roofing, insulation, and flashing were replaced in 2012.

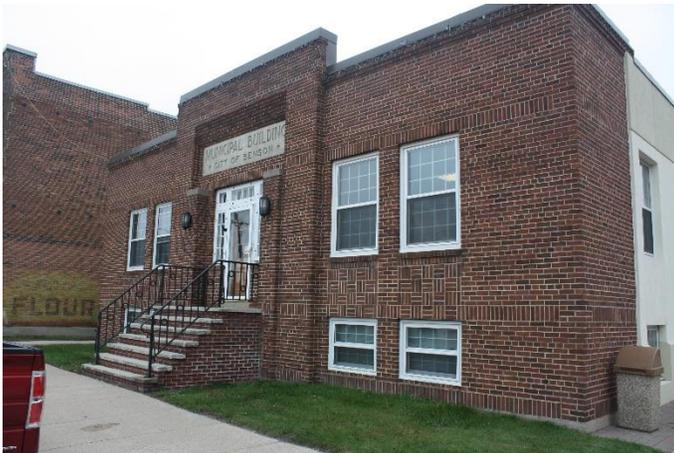
good condition. The face brick is generally in good condition except for specific locations.

- Tuckpoint face brick at specific areas.
Cost Opinion: \$3,000

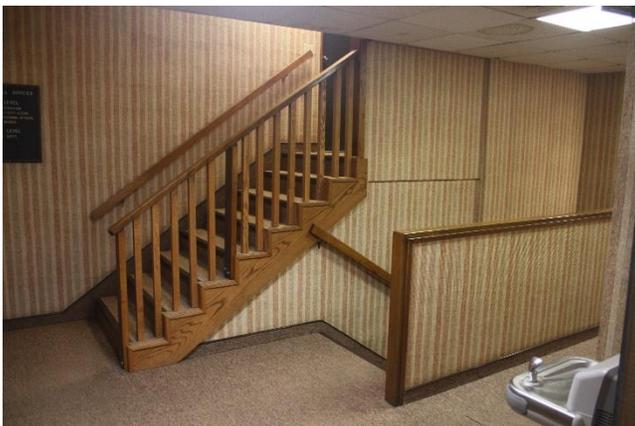
Stairs: Riser and tread dimensions and handrails do not meet current codes.

Most interior doors and frames are in good condition.

- Replace existing interior stairs and handrails.
- Cost Opinion: \$43,000

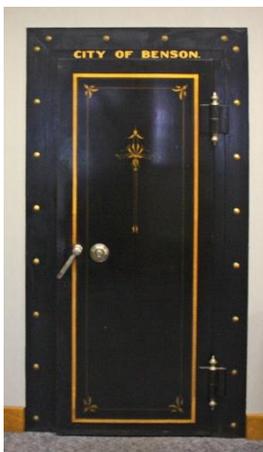
Code comments: Building exiting meets most of the requirements in Minnesota Building Code such as number of exits from spaces and the building, maximum distance to exits, maximum distance to the point where two exits are available, exit width, and minimum distance between exits. One door not meeting code existing requirements is the vault door. There is no way to exit from the vault storage room if the door is closed.

-Alter or remove the vault door lock so that the door cannot be locked and exiting from inside the room is possible without special knowledge or effort per code.

Cost Opinion: \$3,000

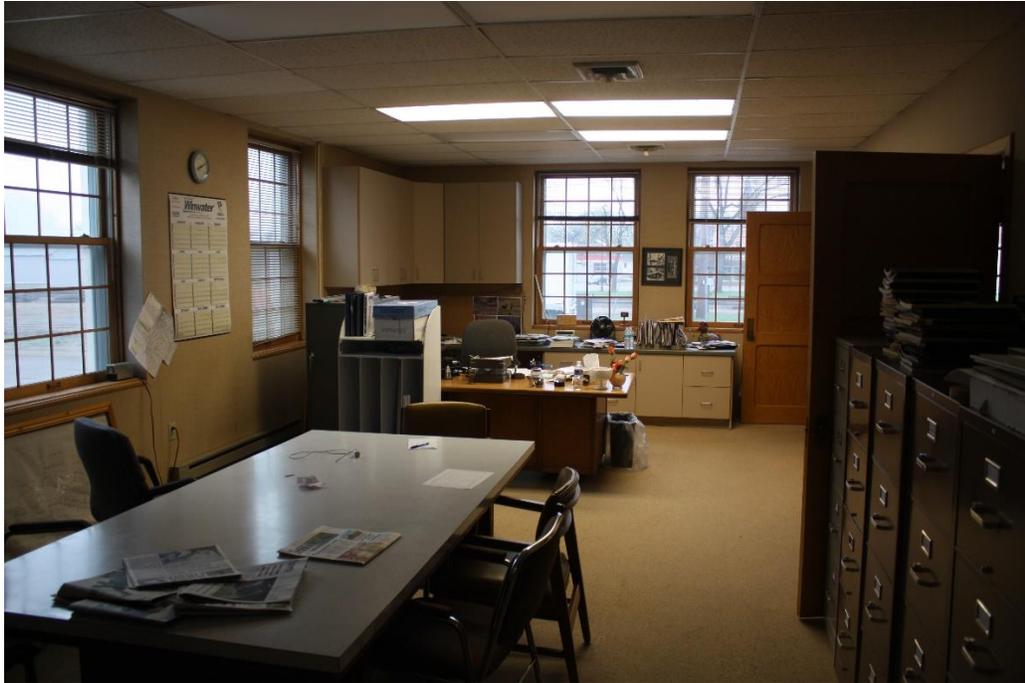
Ceilings, flooring, wall coverings, and painted walls in most areas are worn or outdated.

See recommendation and cost opinion above for removing vinyl wall covering on exterior walls. Remove wall coverings on interior walls, sack, and paint. Repaint existing painted walls. Replace carpet and tile flooring and base in all spaces. Prep floors and other surfaces. Replace existing ceilings, grid, and tile. Refinish existing wood doors and frames where they are discolored or worn.

Cost Opinion for Finishes Upgrades: \$152,000

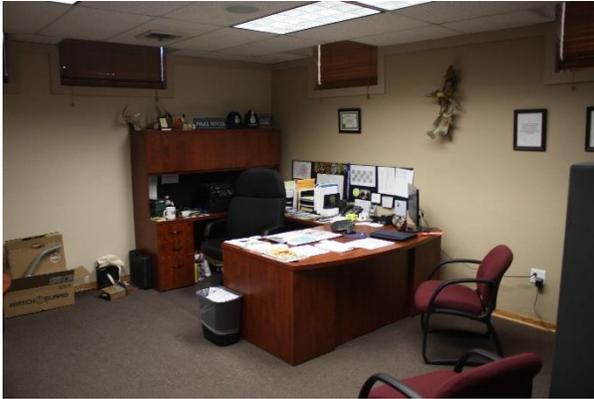
The police department dispatcher does not have visibility of approaching visitors from the main level entrance stairs.

- Rearrange the police dispatch office so visitors approaching the office from upstairs are visible in the downstairs corridor.
Cost Opinion: \$4,000

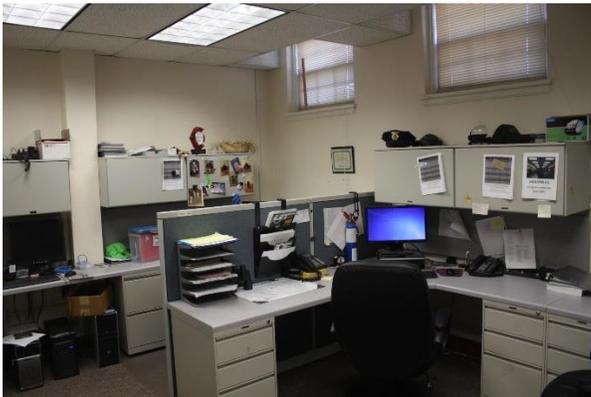
Police department space is too small. Evidence storage and processing areas are too small. No office locker/shower rooms are available. The police department has approximately 5 vehicles that require garage storage. Expanding the basement is not recommended because the cost for constructing a sizeable basement addition to the existing building is not feasible.

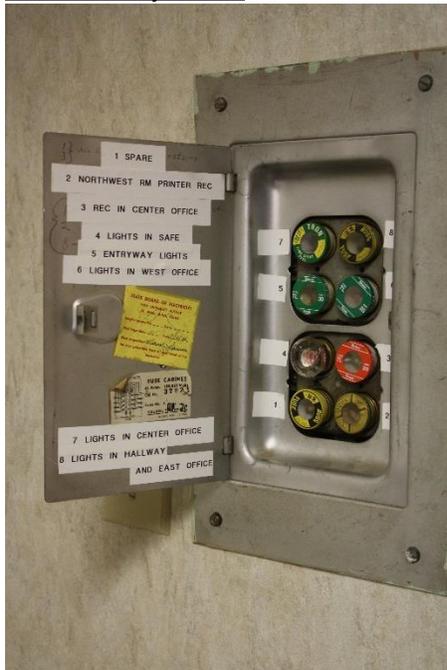
The existing electrical service, panels, and breakers are outdated. Some fuse boxes are present in the building with fuses rated beyond the wiring capacity.

Recommendation: Replace building wiring, fuse boxes, old breaker panels, and verify that the building service is updated to current codes.

Cost Opinion to Upgrade Existing Electrical Power Distribution: \$58,000

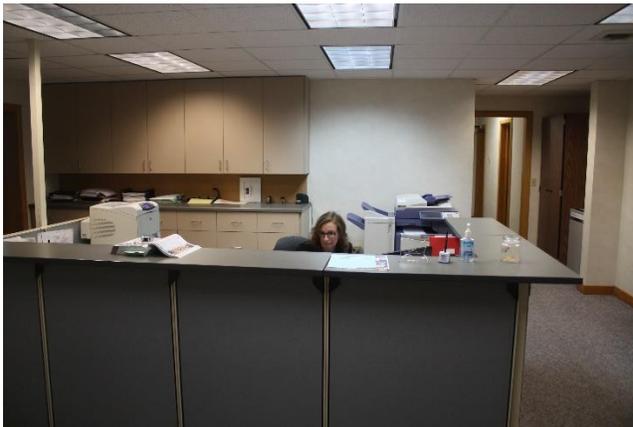
Existing lighting is primarily incandescent and older fluorescent fixtures, which use energy inefficiently. Many exit signs are missing throughout the building and emergency lighting does not appear to be present.

Code Comments: Emergency lighting and illuminated exit signs are required in corridors.

Recommendation: Replace light fixtures with LED fixtures and provide emergency lighting. Replace paper exit signage with illuminated exit signs.

Cost Opinion for Lighting Upgrades: \$47,000
