BENSON CITY HALL/POLICE DEPARTMENT

FACILITY ASSESSMENT AND FEASIBILITY STUDY

**Prepared for the City of Benson, Minnesota
by Widseth Smith Nolting**

May 2016

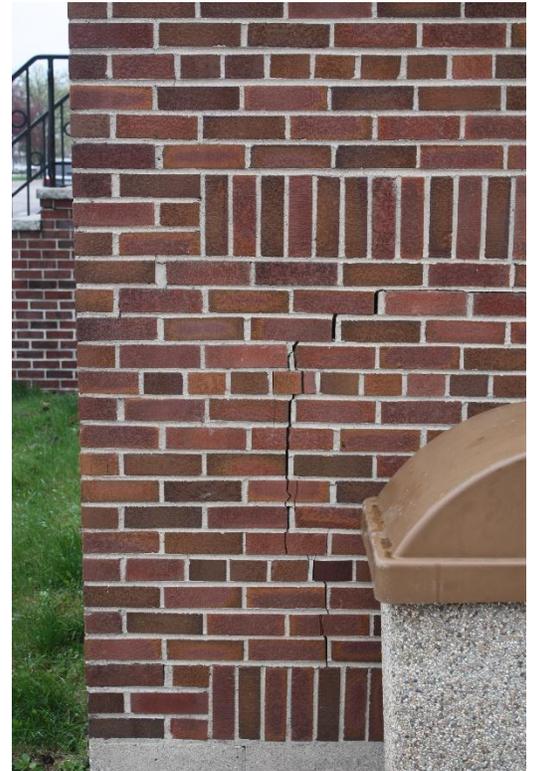
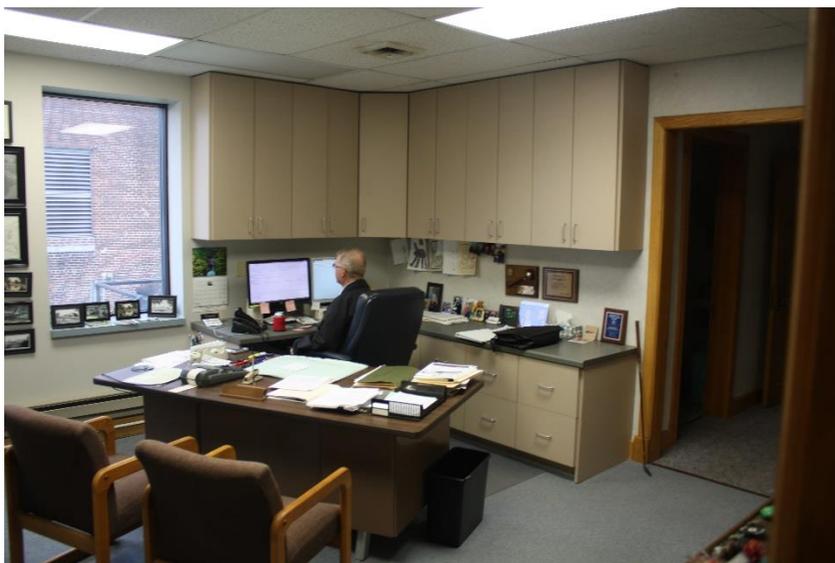
The existing walls above grade are a combination of face brick and EIFS (exterior insulation finishing system which has a finish coating similar in appearance to stucco) on hollow tile block with interior furred drywall. The EIFS application is recent and is in

The interior surfaces of many exterior walls are covered with vinyl wall covering. In recent years, vinyl wall covering has been identified as a material responsible for trapping moisture in walls. The material has a high perm rating and functions as a vapor barrier on the interior surface of the wall. If a vapor barrier occurs elsewhere in the wall construction, moisture becomes trapped between the two barriers and deteriorates wall materials and causes mold development. In addition, the wall covering is becoming detached from the wall in

some locations. We recommend removing the vinyl wall covering.

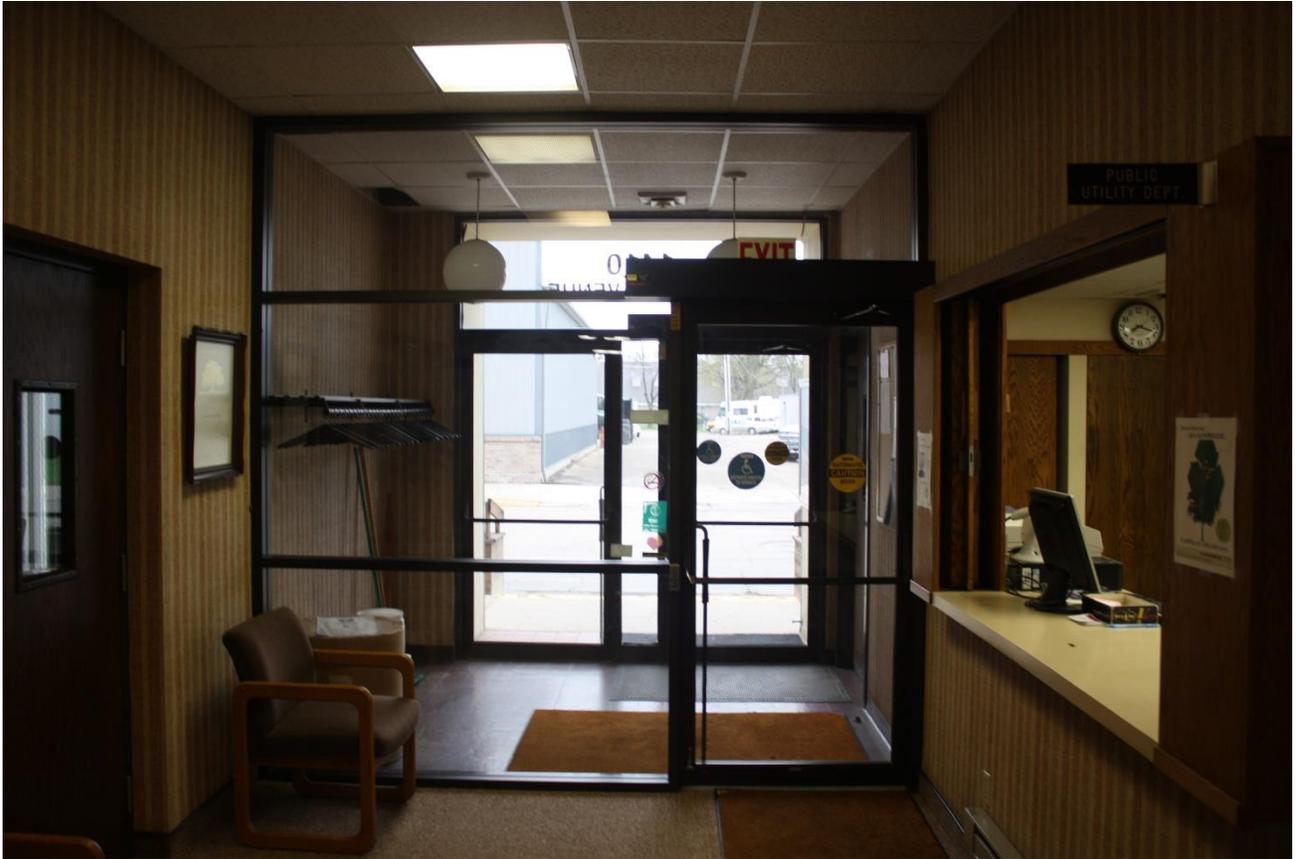
- **Casework**
Most built-in cabinets and counters are in good condition, well-utilized, and distributed throughout the building.
- **Space Functionality**
The office functions on the main level are split by the differences in finish floor heights. The administrative office on the main level uses storage areas on the upper main level, which is less convenient than storing files on the same office level.

The main level lobby is also the entrance lobby for the downstairs police department. The administrative office directs visitors to the police department or to the City staff offices. Because of this functional arrangement, visitors have access to most areas of the building without an escort during business hours. The main entrance does not have a secure lobby where visitors are required to wait for an escort.

The upper main level does not provide good public access to the City staff members.

- Rearrange the police dispatch office so visitors approaching the office from upstairs are visible in the downstairs corridor.
Cost Opinion: \$4,000

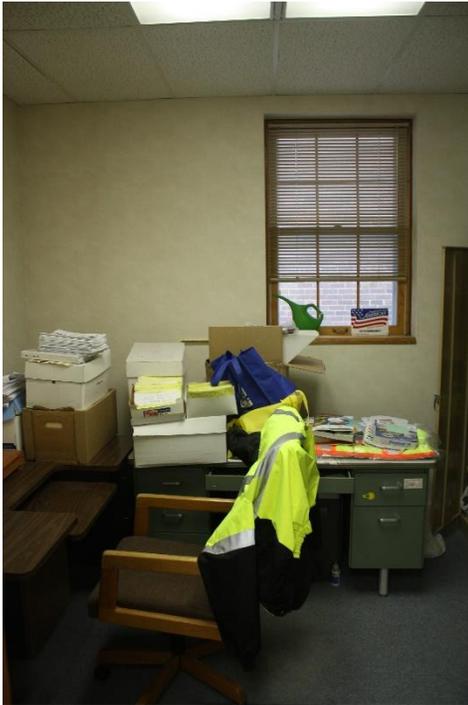
In general, the space available in the building is not used as efficiently as it might be if the space layout and organization were different. In the City staff offices, many rooms are partially used for storage. It is possible for storage to occupy less space in the building if it is organized in one or two rooms with file cabinets, shelves, and other appropriate storage units.

Recommendation: Combine the City staff storage areas to improve storage efficiency. Remodel the police department layout to a plan that works with police processing of evidence and offenders.

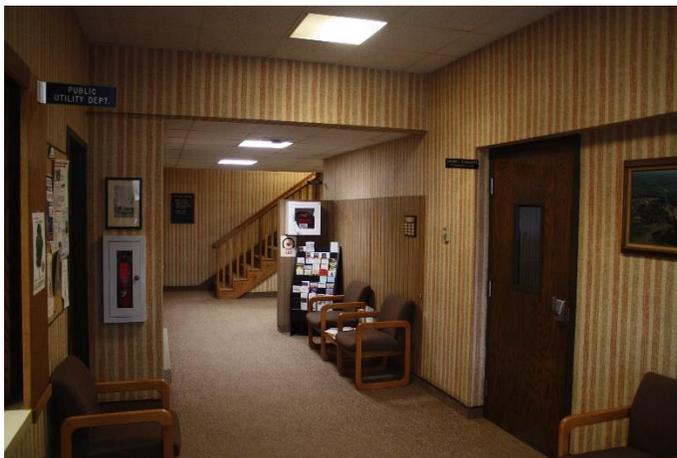
- Main entrance access by police department visitors is the primary security concern in the building.
- Within the police department space, offenders cannot be processed in areas separate from the dispatch and office areas. This situation compromises the safety of occupants and visitors to the police department. Minor adjustments to improve these conditions are possible and included in the Space Utilization costs above.

- Construct a separate lobby entrance for the police department (combined with the elevator addition recommendation above.)
Cost Opinion for Security Upgrades: \$47,000
